NPIC/R-1490/64
September 1964

PHOTOGRAPHIC INTERPRETATION REPORT

MUNITIONS STORAGE SITE NEAR HSU-CHOU, CHINA

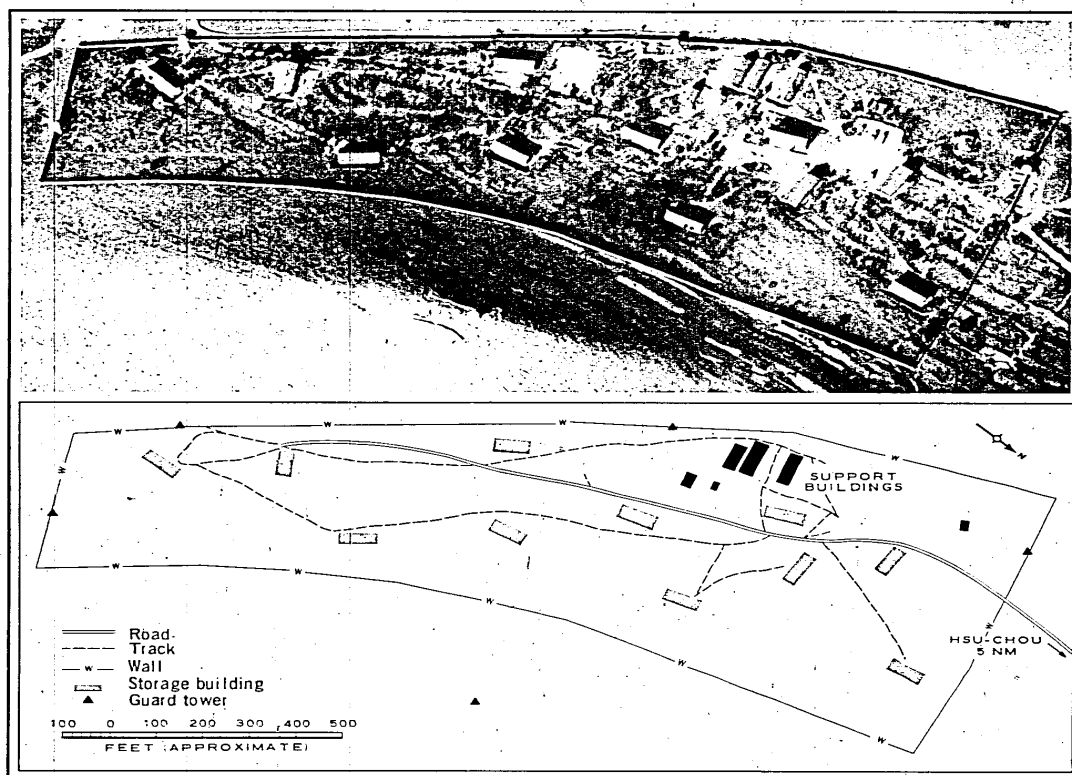
FIGURE 2. MUNITIONS STORAGE SITE NEAR HSU-CHOU, CHINA, [REDACTED]

Storage Buildings. The site contains 11 warehouses and six smaller support buildings (Figure 2). All of the buildings have gable roofs and lack ventilators or other rooftop gear. The buildings are not revetted nor do they have other

features which would indicate explosives storage; however, seven have low water-diversion walls on their uphill sides. The storage buildings measure 75 by 30 feet; the total floorspace of the 11 storage buildings is 24,750 square feet.

Security. The site is surrounded by a high wall and is protected by two guard towers on the downslope wall on its WSW side and one tower on each end wall of the site. The upslope wall on the ENE side has no towers but is protected by a tower at the top of the hill near which the site is located.

Housing and Administration. In addition to the storage buildings, the site contains six support and maintenance buildings. No nearby housing and administration area is present, although a small rural settlement is located a few hundred feet from the site's gate.
